# Scaff Safe 2021 Findings Report

March – June 2021

This report provides a summary of the findings from construction site visits that were undertaken state-wide between 22 March – 13 June 2021, for the Scaff Safe 2021 inspector visit program and campaign.

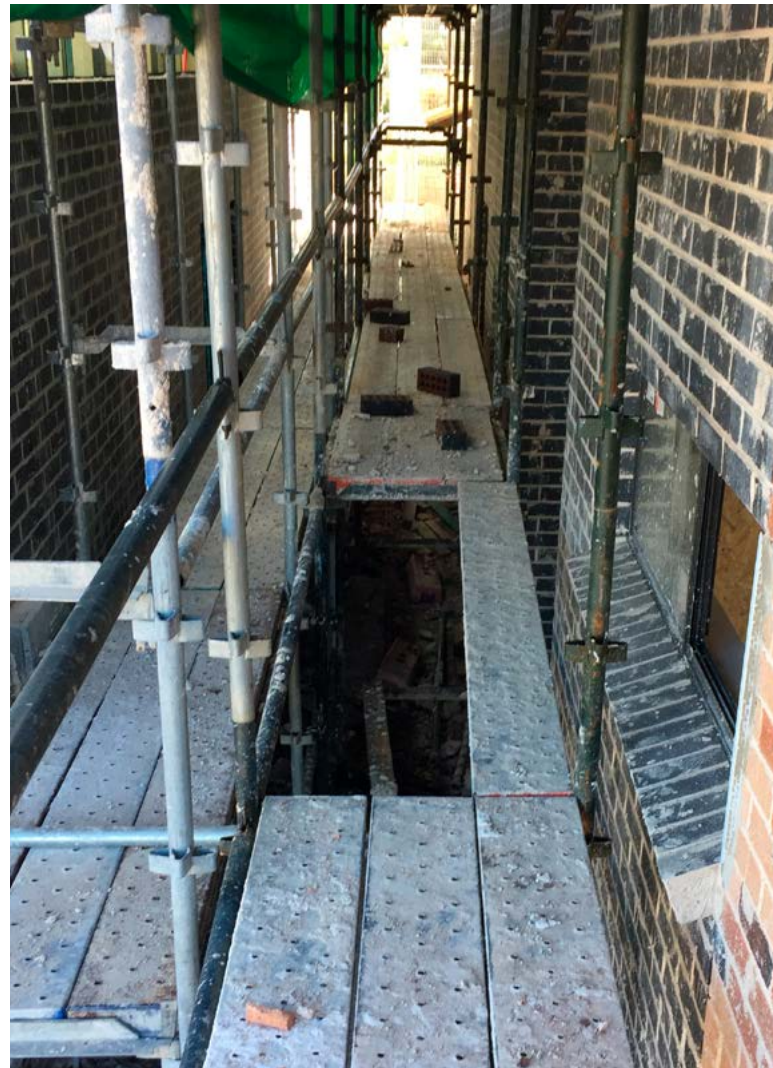
During Scaff Safe 2021, inspectors observed an unacceptable level of missing components on scaffolds, including missing ledgers, planks, hop-ups, mid rails and handrails.

**43%** of sites had working decks with missing ledgers, planks or hop-ups.

Picture 1: Scaffold with missing planks

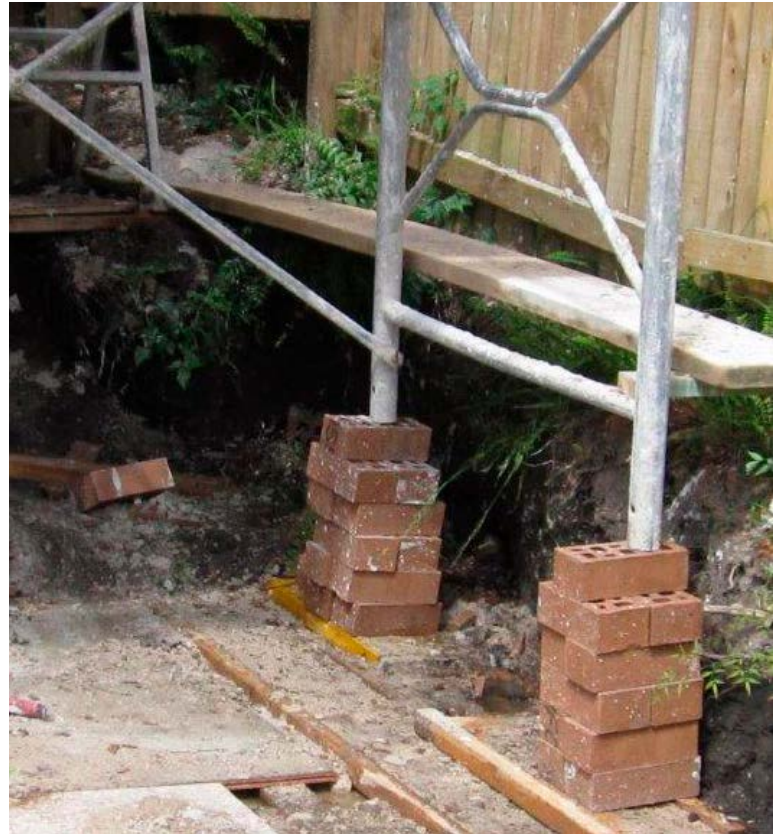
Picture 2: Scaffold on an unstable foundation.

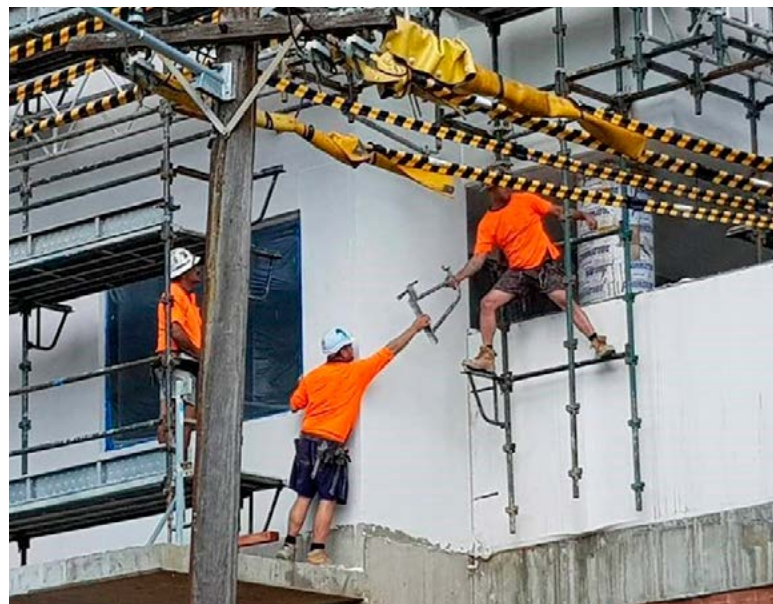
**49%** of sites had principal contractors who did not prevent workers accessing incomplete scaffolds.

Picture 3: Workers accessing incomplete scaffold and misusing it.

The principal contractor and site supervisors have critical roles and obligations to ensure the safety of workers when using scaffolds. This includes ensuring the scaffolds remain safe and compliant for the duration of the construction project and that workers are not accessing incomplete sections.

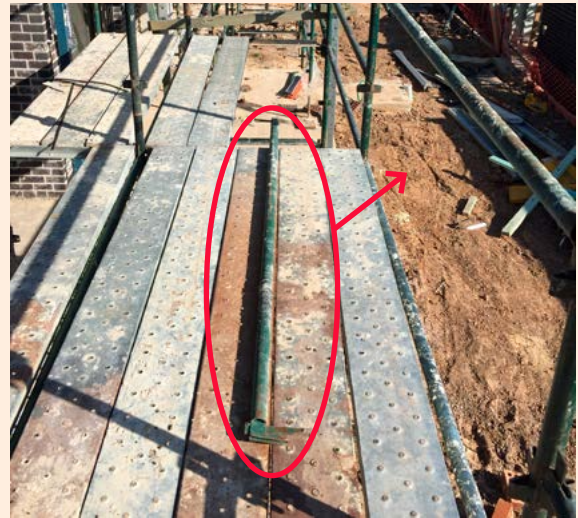
**30%** of sites had scaffolds that had been altered by unlicensed tradies.

Picture 4: Scaffold with mid rail removed.

Workers who use scaffolds must not alter or tamper with a scaffold if they do not hold a scaffolding high risk work licence, and must not misuse the scaffold.
