Position paper - removal of asbestos waste from sites

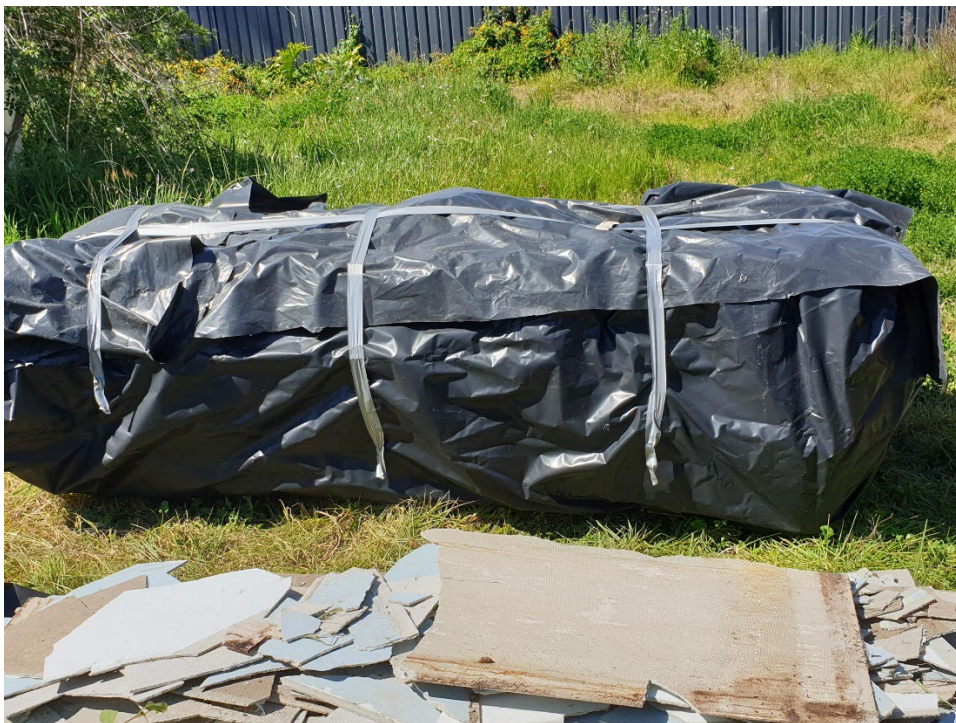
Photo1: Example of an asbestos waste “parcel” not suitably sealed, contained or secured in a manner that facilitates its future safe disposal

Inspectors have observed such parcels are often inadequately sealed for mechanical lifting, and not labelled as being ACM, including instances where a clearance certificate has been issued but an asbestos “parcel” remains on site.

Where exceptional circumstances exist and asbestos waste cannot be taken off site and disposed of at the time of removal, then it must be suitably sealed, contained and secured in a manner that facilitates its future safe disposal. This means where the contents cannot be disturbed, and the waste container can be readily relocated for transport. E.g. the waste is contained within an enclosed skip or other container designed for the containment of asbestos waste.

Where asbestos waste is not promptly removed from site it must be secured. E.g. padlocked skip or fencing around the waste. The skip or fence must feature asbestos warning signage “Danger Asbestos” on the outside. This is in addition to labelling of the actual waste.

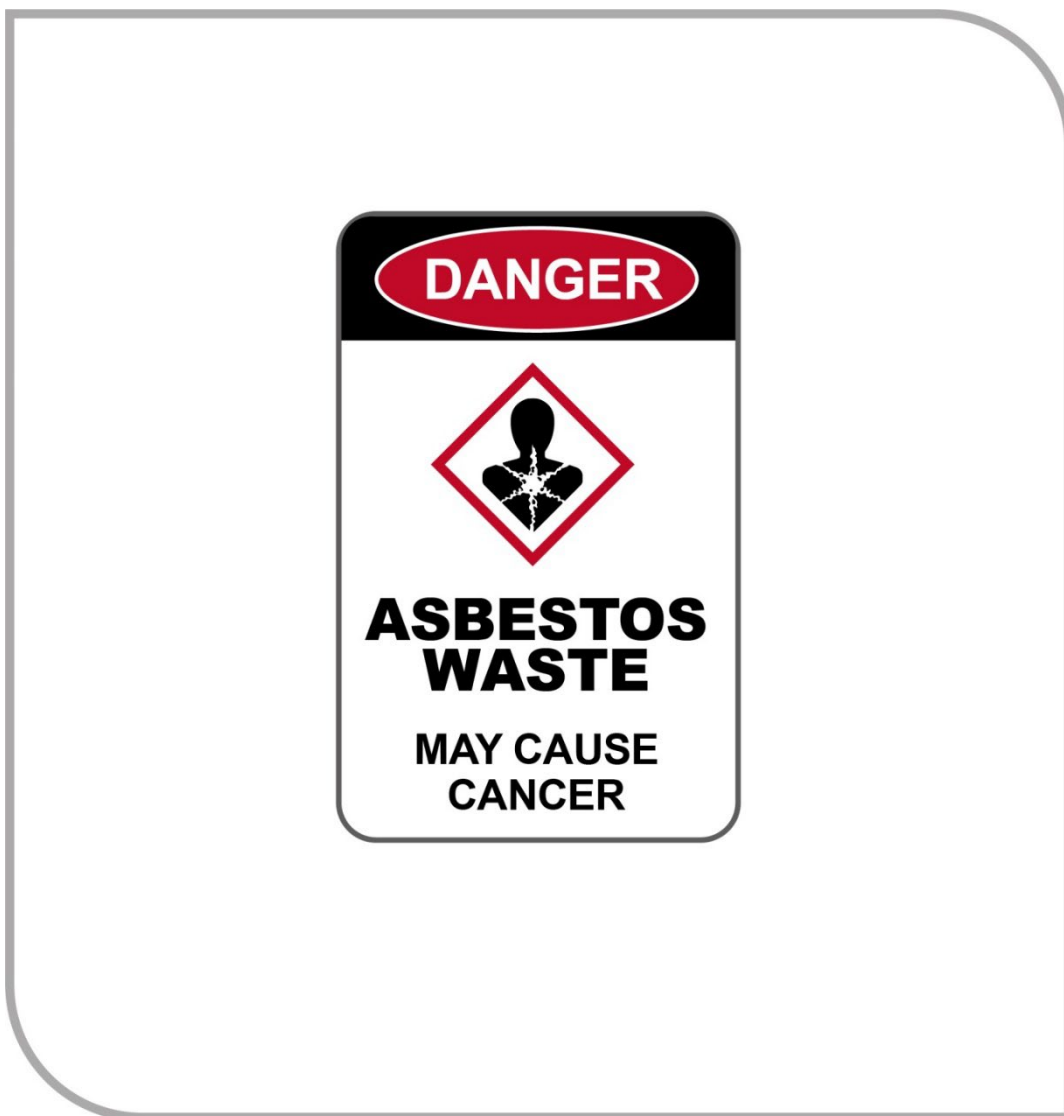
All asbestos waste must be suitably double bagged or securely double wrapped in minimum 200µm plastic sheeting AND labelled in accordance with the GHS as asbestos waste. This means that the labelling needs to feature the word “Danger” AND the phrase “May cause cancer if inhaled” AND must also display the graphic below: as per Clause 472 (a)

Figure 1 Example of an asbestos waste label

Labelling needs to be clearly visible: this means applying multiple labels to the waste or using pre-labelled packaging.

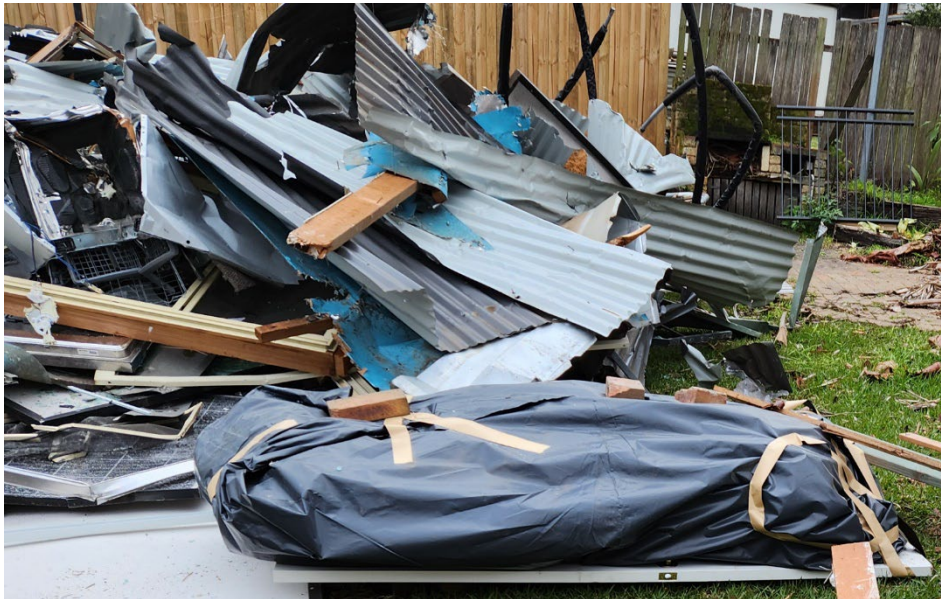
Photo 2: Example of asbestos waste “parcel” not suitably sealed, contained and secured in a manner that facilitates its future safe disposal

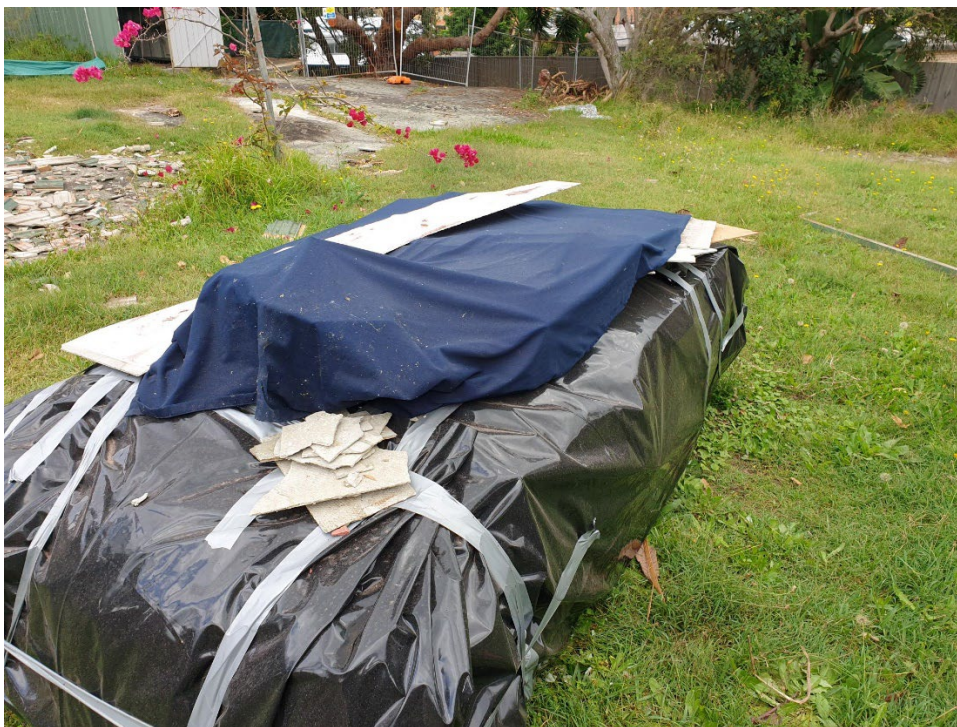
Photo 3: Example of asbestos waste “parcel” not suitably sealed, contained and secured in a manner that facilitates its future safe disposal, with apparent additional unwrapped asbestos-containing material added.
